PAGAN newsletter 1987

Conservation of Pagan monuments

is published once a year by the UNDP/UNESCO project BUR/81/032 "Conservation of Cultural Heritage at Selected Sites in Burma".

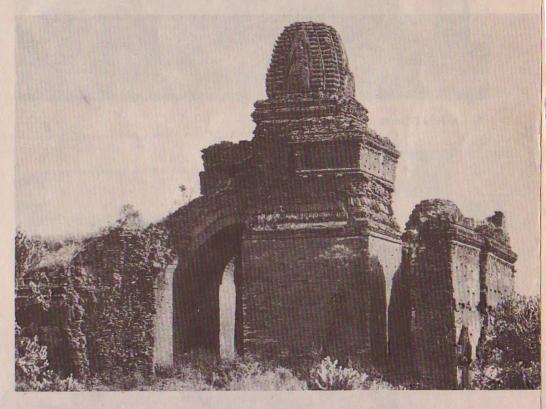
But the lesson was learned, and the Department of Archaeology decided to undertake restoration work on a neighbouring temple very much in the same condition: the Hlaing She temple No 369, near Alopyi temple, is another early monument from the 12th century AD, of nearly the same size. Here again the vault of the corridor, except for its eastern side, collapsed long ago and the northern wall is totally destroyed. The western and southern walls, though still standing, are split by several open vertical cracks.

Hlaing She temple No 369, from North-West. Notice the solid central core, the upper storey and the square tower, presently isolated since the corridor yault has collapsed.

Reconstruction of the northern wall begun in 1987 from its foundations. After repairing the cracks, all walls will be linked together by a reinforcement belt, and the vaults of the corridor will be rebuilt on all sides. The monument will thus regain its structural integrity, and the upper masonry parts will finally be repaired and waterproofed.

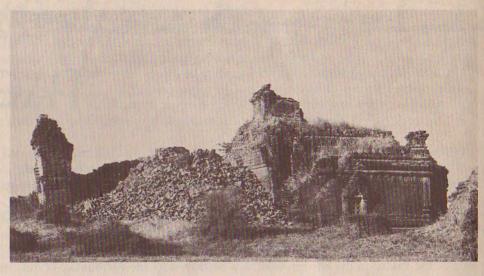
After a few days of rain in October 1986, the whole tower of temple No 433 caved in suddenly. The temple was already half ruined, as the northern and southern walls of its corridor, together with its vault, has collapsed long ago. The remaining part of the vault, on the eastern side, was destroyed by the earthquake of July 8, 1975. Up to 1986 however, the central rectangular shrine which is now buried below the debris of the tower, still had its Buddha image as well as mural paintings on its walls and under its vault. A fine example of stucco carving adorned the upper portion of the square tower.

Temple No 433, same view, January 1987 after the collapse of the tower.
